From black to white (box) attacks on secure systems: or why do your light bulbs need a firmware update

Eyal Ronen

IoT Goes Nuclear: Creating a ZigBee Chain Reaction

Eyal Ronen, Colin O'Flynn, Adi Shamir, Achi-Or Weingarten

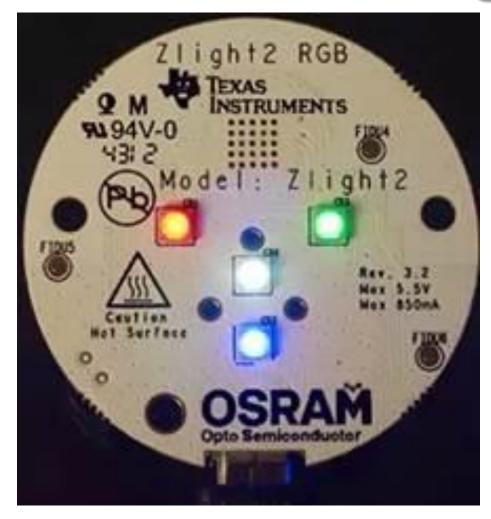
We bought a cheap and lightweight commercial Zigbee evaluation kit:

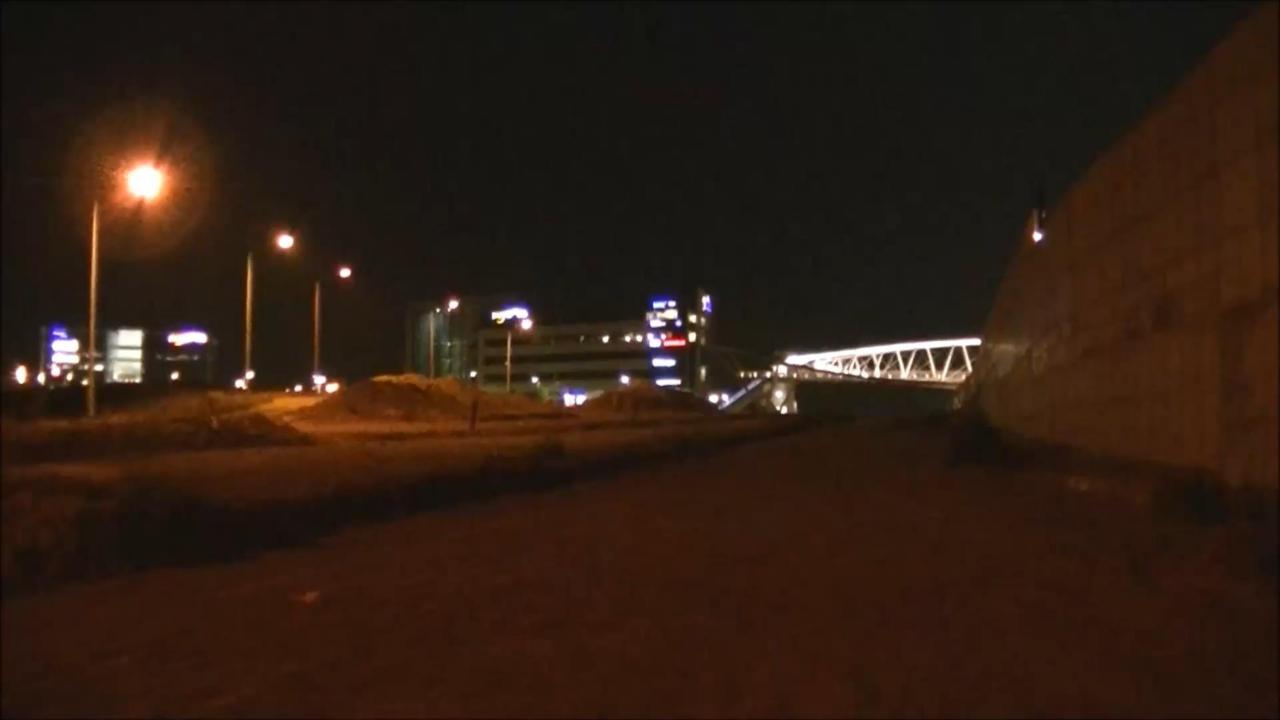
By launching a drone carrying a fully automated attack equipment 400 meters away
